Testing for Certification of CVM™ Sensors on the 737NG Aft Pressure Bulkhead

ABSTRACT

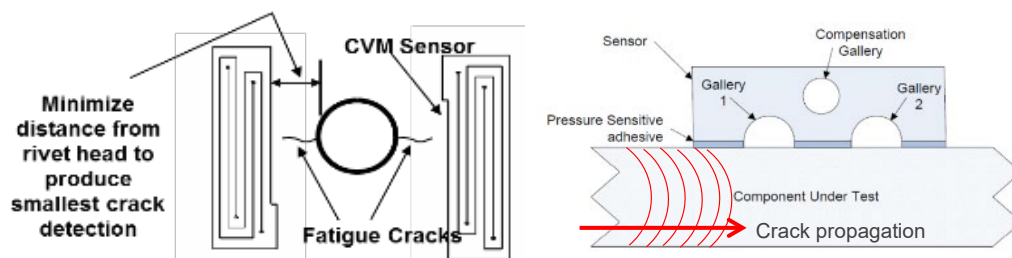
Figure 1. How the Comparative Vacuum Monitoring (CVM) sensor works

The CVM sensor that Boeing is using was developed by Structural Monitoring Solutions (SMS) and Anodyne Electronics Manufacturing (AEM) Corp. The CVM sensors are manufactured from multiple layers of fluorinated ethylene propylene (FEP) sheets, laminated together with an acrylic pressure-sensitive adhesive. The same adhesive is on the bottom layer and facilitates the adhesion to the aircraft. Sensor shapes are fully customizable, allowing for specific crack detection sensitivities, targeting specific crack lengths, and specific sections of the aircraft. Each sensor has three lasered channels called Gallery 1, Gallery 2, and the Compensation Gallery (Fig. 1). Galleries 1 and 2 are exposed channels on the base of the sensor and become sealed once the sensor has been installed onto a component surface. Instrument readings from Galleries 1 and 2 are used to identify the presence of a crack while the purpose of the Compensation Gallery is to provide a stable reference which improves the signal-to-noise ratio that have been influenced by environmental conditions such as temperature and humidity. Sensor Lead Socket (SLS) leads provide the ability to route the sensor network to a convenient location that's easy to access in the aircraft. When an inspection is required the socket mates to the pneumatic plug on the PM200 Instrument Lead completing the connection between the sensor network and the PM200 test instrument.

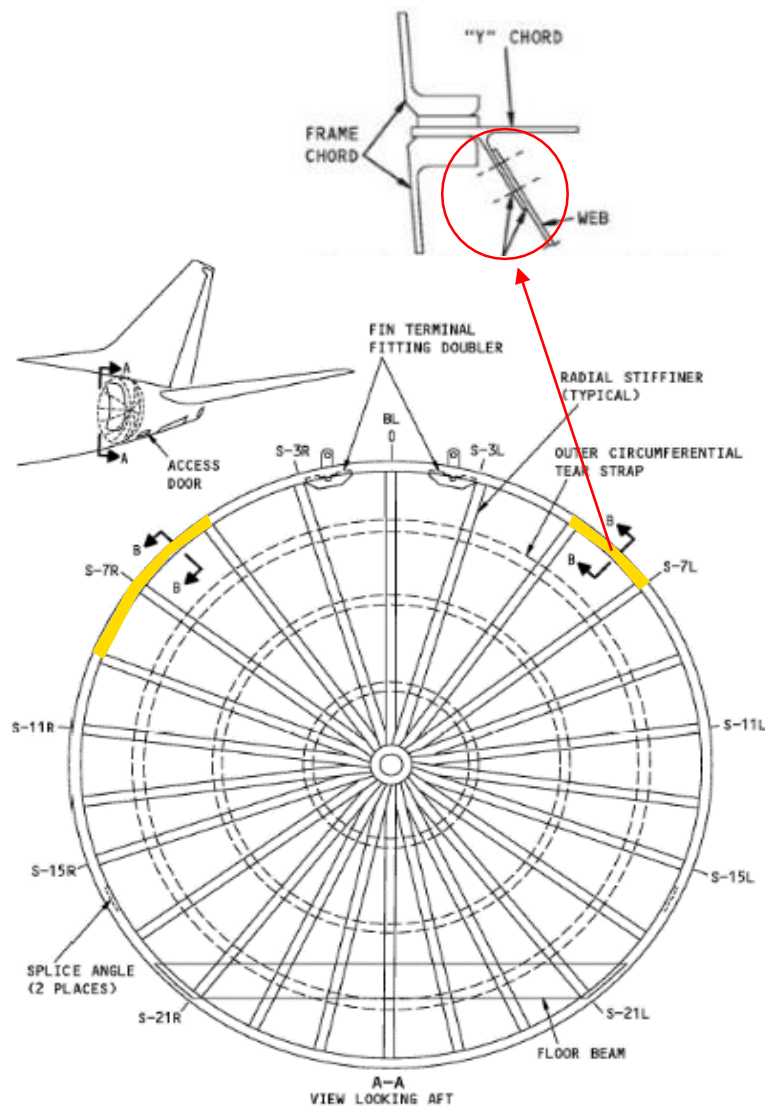
Figure 2. Frequent inspection area on 737NG aft pressure bulkhead

In 2018, SMS and Delta TechOps partnered to create a CVM solution for the 737NG Aft Pressure Bulkhead (Fig. 3) for Service Bulletin (SB) 737-53A1248. This is a safety bulletin due to reported in-service cracks on the 737 classic models and is mandated by the FAA with an Advisory Directive, AD 2005-21-06 & AD 2016-18-15. CVM sensors will be installed at the critical location - the web to “Y” chord attachment between stringers 5 to 7 on the left side and stringers 5 to 9 on the right side. This area has inspections that do not align with regular maintenance intervals. The bulletin allows operators two inspection methods – low frequency eddy current (LFEC) from the aft side every 1,200 flight cycles or high frequency eddy current (HFEC) from the forward side every 3,800 flight cycles. The aft inspections are difficult due to the small access space and the forward inspections require the removal of the aft galley. The proposed CVM option will demonstrate equivalency to LFEC and utilize the same inspection interval. The CVM system is expected to reduce the inspection time (including access) from 24 hours to 15 minutes.

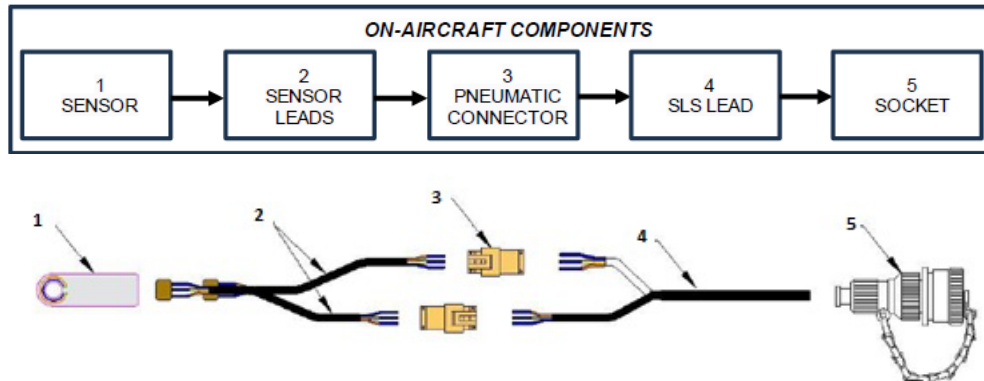
Figure 3. On-aircraft components tested

A set of functional tests were performed to validate that the CVM system can function in a variety of conditions – temperature, humidity, altitude, vibration, icing, and tension. See Figures 3 and 4. These tests did not involve detection of a crack. The components of the systems were exposed to ensure the system could function after being subjected to environments. Boeing was able to leverage tests from the prior wing box fitting tests performed at the supplier and SANDIA. Only tension tests were needed to be performed during the CVM project.

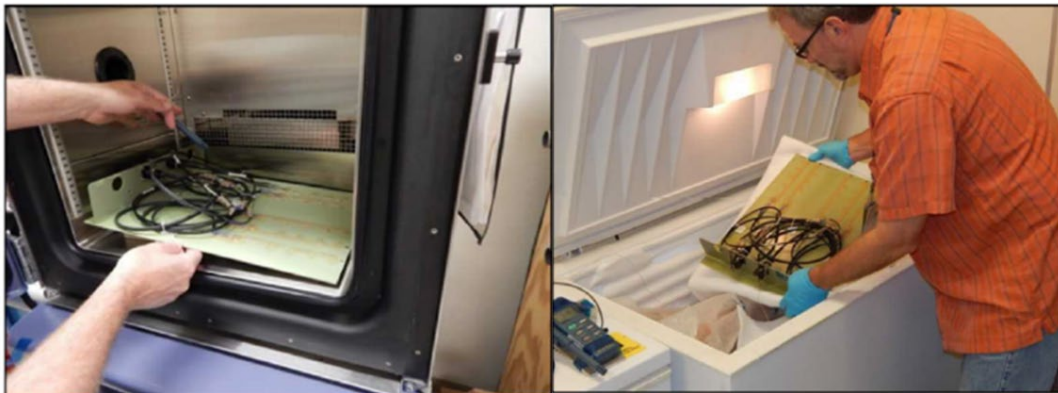
Figure 4. Components being tested

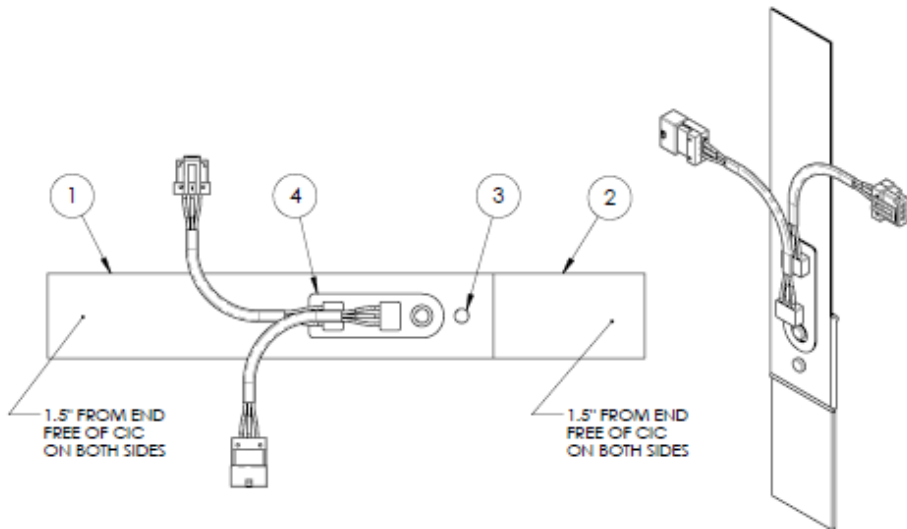
- 1 Test Coupon, 737 APB, 0.032" Web
- 2 Test Coupon, 737 APB, 0.080" Y-Chord
- 3 Rivet, Solid Aluminum, 5/32" x 0.250"
- 4 Ring Sensor 8.62 mm, MF, 2x3, 120mm

Figure 5. Test coupon

Additional tests (Figures 5 and 6) were performed to validate that the CVM system can detect cracks within the operating conditions on the ground. Cracks were grown under both high and low stress levels. Once a crack was detected, the coupon was subjected to temperature, humidity, altitude, icing, and compression. The initial crack detection data was used to generate a probability of detection (POD) to validate that the system was equal to or better than the traditional NDI inspection it was replacing.

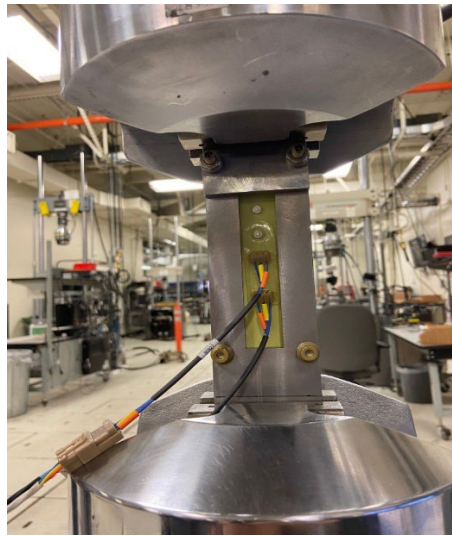
Figure 7. Compression Test Setup

Additional tests were performed to validate the CMV system can detect cracks under compressive loads that could close the air leak path. A special fixture was designed to prevent the coupon specimen from buckling (Figure 7). POD coupons with existing detectable cracks were used to show that there is no effect in detection for configuration.

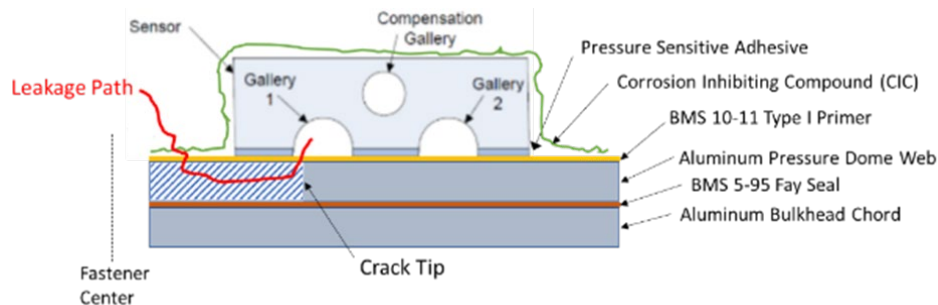
Figure 9. Air Leak Path for CVM sensor

Additional tests were accomplished at extremely low stress to validate that the primer and CIC surface finish would separate under the extremely low stress levels and allow an air leak path for CVM sensor detection (Figure 9).
