Corrosion Identification, Location and Assessment of Prestressing Tendon Anchorages in Suspension/Cable-Stayed Bridges: Integrating Image Recognition and Machine Learning with Acoustic Emission Method

ALEKSANDRA KRAMPIKOWSKA and GRZEGORZ SWIT

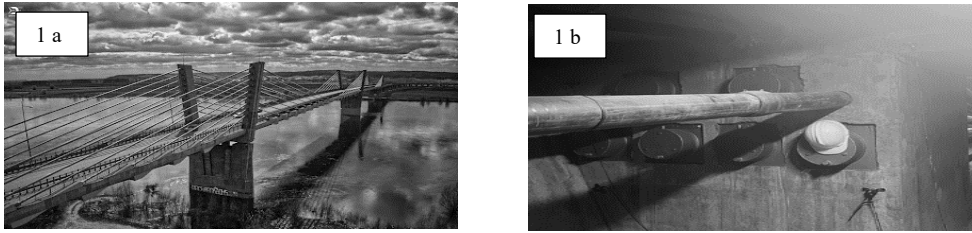
Figure 1. View of the bridge (1a) with an internal anchor block for prestressing cables (1b)

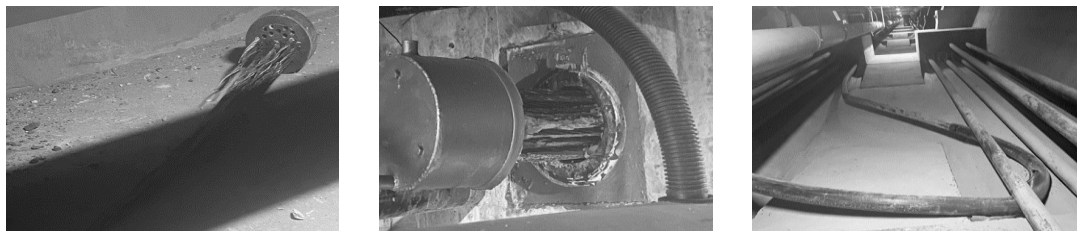
This research project used acoustic emission to investigate selected structural components of a road bridge spanning the Vistula River near Kwidzyn (National Road No. 91, between Korzeniewo and Opalenie). The structure is an 808.5 m long extradosed, concrete box girder bridge (including 1862.5 m access viaducts), with a main span of 204 m. The study focused on eight reinforced concrete blocks anchoring prestressing cables within the bridge's box girder. Bridge Management data indicated three prestressing cable failures due to corrosion between 2021 and 2024 (examples in Figure 2).

Figure 2. Corrosion of prestressing strands in the anchor block

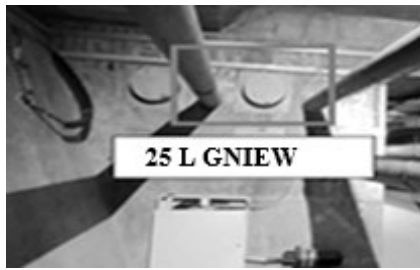
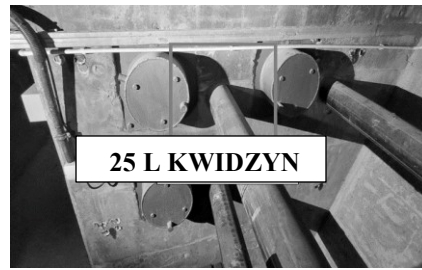
Figure 3. Representative abutment block subjected to AE testing.

The field investigations involved acoustic emission (AE) monitoring of crossbeams No. 22, 23, 25, and 26 (Figure 3). Eight sensors (four per side) were installed on each block to detect potential abutment block defects (cracks), cable corrosion, or incomplete grouting. This allowed both surface and spatial localization of AE sources. Investigations used a 24-channel AE processor with AWin and NOESIS 12 software, along with VS-75 flat-response sensors with integrated preamplifiers.

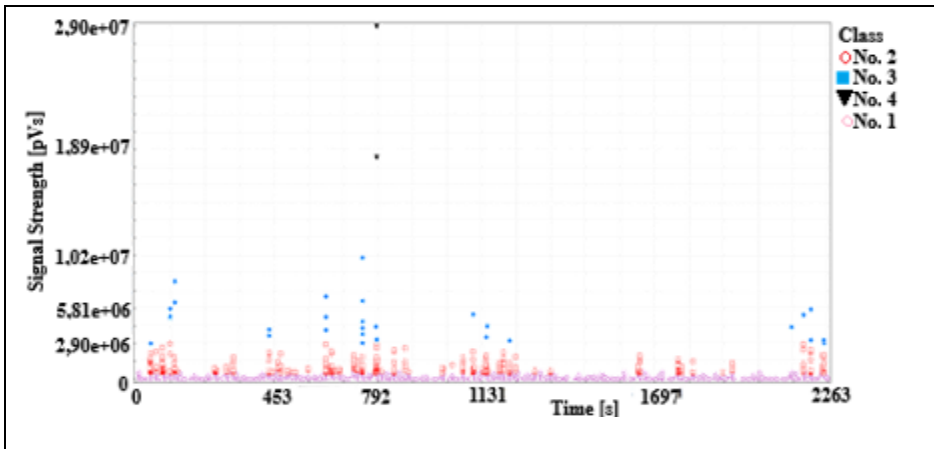
Figures 5 and 6 present graphs of selected AE signal parameters (strength and duration) from monitoring crossbeams 25L and 25P, analyzed using pattern recognition. Scanning the upstream side of block 25P revealed weak signals, possibly indicating minor voids in the concrete and the development of cracks within the anchor block. No signals suggested cable corrosion (Figures. 5a and 5b). Figures 5a, 5b, 6a, and 6b show that signals marked No. 3 indicate the initiation and propagation of new cracks (duration $\leq 100,000 \mu\text{s}$). Signals No. 4 indicate crack propagation. These existing defects are typical during anchor block operation and did not affect its safe service life at the time of investigation. Scanning the downstream side of block 25L (Figures 5b and 6b) revealed strong signals indicating minor voids, inadequate vibration, crack development, prestressing cable corrosion (No. 5), and fracturing of individual cable fibers (No. 7 and No. 8). Signal strength was up to 10 times greater than that in block 25P. Signals also indicated cable corrosion (Figure 2). Signals No. 3 indicate new crack initiation and propagation (duration $\leq 120,000 \mu\text{s}$). Signals No. 4 and No. 5 indicate crack propagation, debonding, and concrete-concrete friction. Signals No. 7 and No. 8 indicate steel corrosion and fiber fracturing. Defects No. 1-5 are standard during operation and did not affect safe service life. However, signals No. 7 and No. 8 indicate unsafe corrosion and fiber fracturing in the prestressing cables.

Figure 5a. Scatter plot of signal strength versus time for anchor block No. 25P .

- replacement of the identified prestressing cable after confirmation of damage.
3. During the investigation of anchor block 25P under traffic load, the locations of crack initiation and propagation locations were identified. Information regarding destructive processes occurring in the prestressing cable due to corrosion, confirmed by GalvaPULS testing, was also obtained. Currently, due to the high dynamic loads induced by transit traffic on the structure, it is recommended to perform acoustic emission testing at least twice a year (April and September) to monitor the intensity of crack propagation and the development of corrosion processes in the prestressing cable.

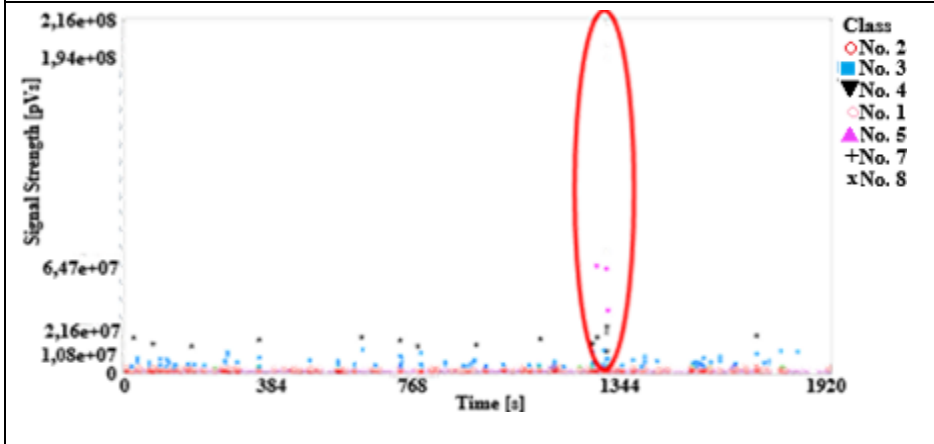
Close analysis of the red area in Figure 5b identifies the location of corrosion and fiber fracturing within the anchor block.

Figure 5b. Scatter plot of signal strength versus time for anchor block No. 25L.

2. In anchor block 25L, signals indicating destructive processes occurring within the prestressing cable, specifically the fracturing of individual fibers, were recorded. Therefore, the following is recommended:

- mechanical intervention within the cable anchorage and removal of the cover to confirm the findings, OR
 - periodic monitoring of the indicated area on the abutment block (minimum measurement every 2 months), OR

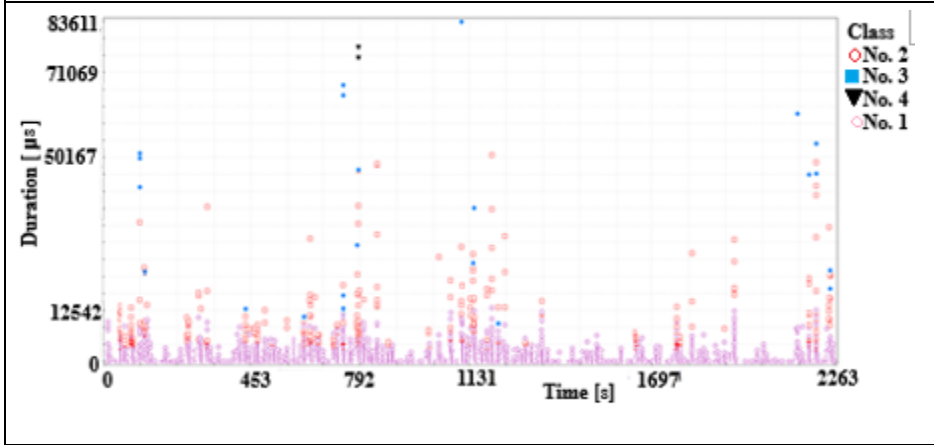
Figure 6a. Scatter plot of AE signal duration versus time for anchor block No. 25P.

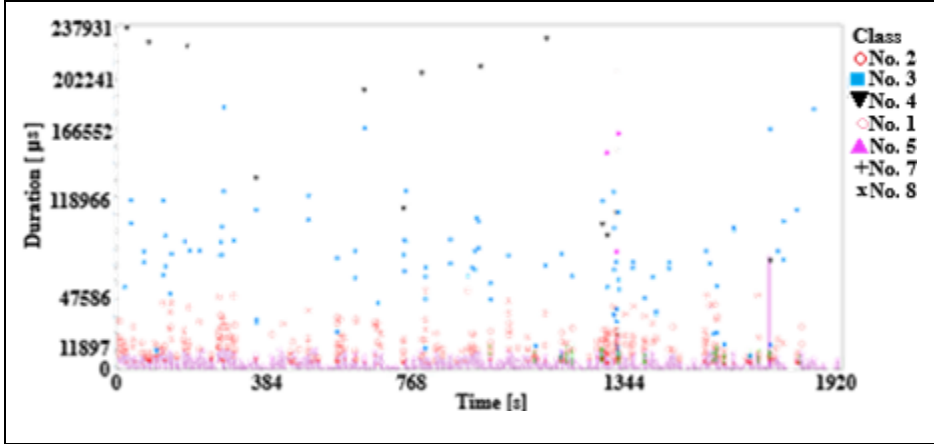
Figure 6b. Scatter plot of AE signal duration versus time for anchor block No. 25L.
