A Study of the Temporary Bridge Crossing for Appalachia After Hurricane Helene

SHEN-EN CHEN, HOWARD CHUNG*, PAUL SUMITRO,
JING QIONG HU, ALIREZA MORTEZAYIAN
and MALCOM HODGES

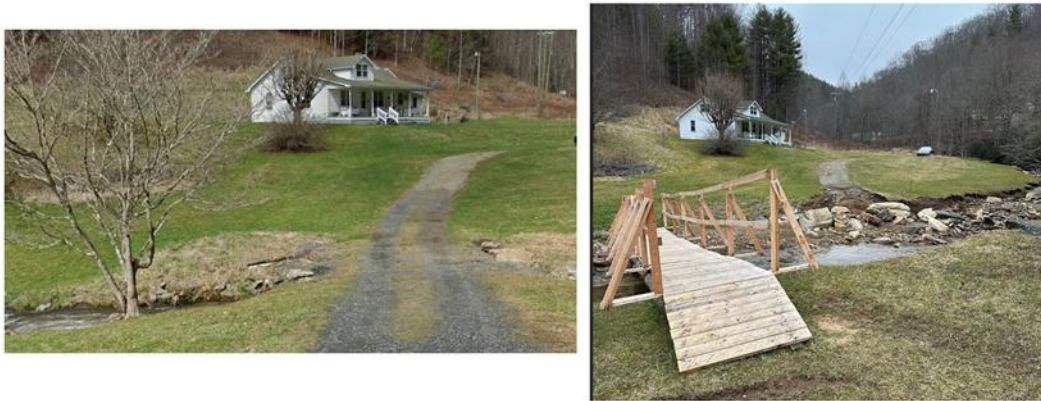
Figure 2. Local Crossing (PO141) in Creston, NC, 377% Channel Width Widened

Table I summarizes local crossing failures studied in Ashe County, NC, where bridge structures were swept away and channel widths at the crossing sites increased by as much as 300% of their original size as in Figure 2, highlights the failed local stream crossing in Creston, NC, where a washed-out culvert was in a stream that experienced a 377% increase in channel width. Before-and-after images of the site are shown in Figure 3. Most of these failed crossings were over 20 years old, and their destruction underscores multiple vulnerabilities: Limited capacity to accommodate floodwater, insufficient resistance to scour, and a lack of structural support to withstand the hydrodynamic forces of extreme flooding.

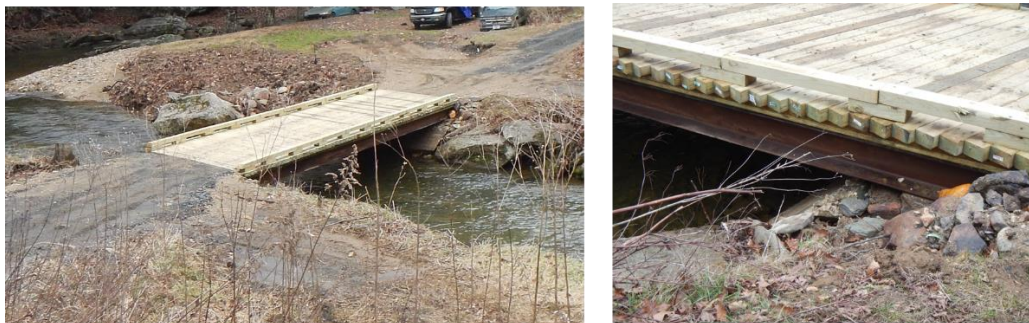
Figure 3. Typical temporary bridge built after Hurricane Helene in Wester

Recovery efforts—including temporary bridge installation, stream realignment, and sediment removal—are rapidly progressing but can vary widely in quality and approach. Intended for either single car crossing, most of the temporary bridges built are steel girder bridges with wood decks as seen in Figure 3. Even though these bridges are designed for temporary crossings, it is still critical to ensure their structural integrity is consistent with design requirements.

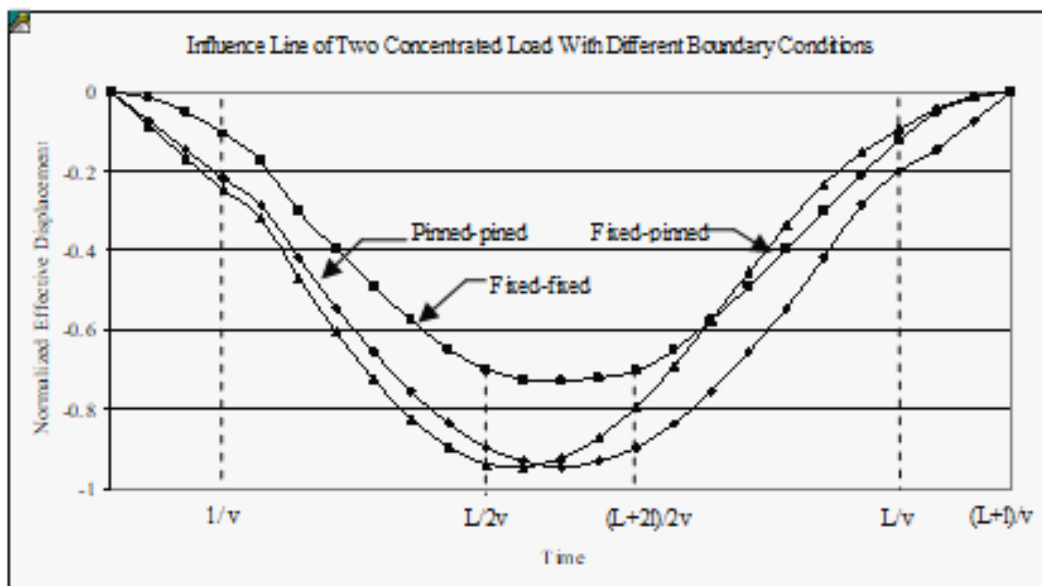
Figure 6 Modified Dynamic Bridge Model with Different Boundary Conditions

effect, and $F_{vt}(t)$ is impact force from vehicle motion. Figure 6 shows the modified mode shapes computed from vehicle loads applied at different locations.
